TOWN OF OCCOQUAN
ARCHITECTURAL REVIEW BOARD
DESIGN GUIDELINES MANUAL

Prepared by the Architectural Review Board
Adopted November 2005
Updated October 2022; August 2023

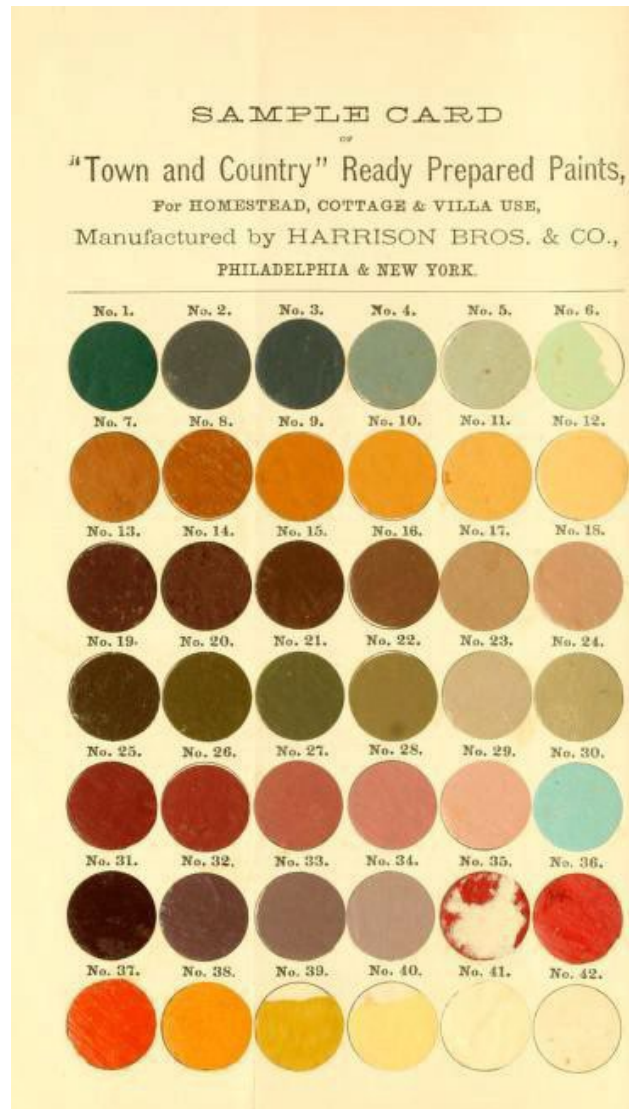
The book *A Century of Color* is an excellent reference. Another resource is the following color chart which is taken from the website Archive.org and the document “Every Man His Own Painter!” which was originally written in 1872.

Note that none of these colors are modern paint chips. Use these colors as a guide as you pick out your exact paint colors. Most popular exterior paint brands now have historic palettes available.

Exterior paint colors shall be appropriate for the architectural period of the building. Colors of a building shall take into consideration roof and foundation colors. It is encouraged that when rehabilitating Craftsman or Victorian style homes to use period-appropriate color pairings. In addition, for rehabilitation or replacement of windows, “earth tone” colors are appropriate.
